## Parts Catalog - Option Detail

Electronic Parts Catalog - Option Detail				
Option	Group	Graphic	Film Card	Date
BR9039-04	03.02	br941ga	Z	09-AUG-99
<b>Engines</b>	6C8.3, C GAS PLUS CM556, G8.3, G8.3 CM558, GTA8.3 CM558, ISC CM2150, ISC CM554, ISC CM850, ISC8.3 CM2250, ISC8.3 G CM2180 C101, ISL CM2150, ISL CM554, ISL CM850, ISL G CM2180, ISL8.9 CM2150 L110, ISL8.9 CM2880 L112, ISL9 CM2150 SN, ISL9 CM2250, ISL9 CM2350 L101, ISL9 CM2350 L111, ISLE4 CM850, L GAS PLUS CM556, L8.9, L8.9 L121, L8.9G CMOH2.0 L125B, L9 CM2350 L116B, L9 CM2350 L119B, L9 CM2350 L120C, L9 CM2350 L123B, L9.3 L105, L9.5 L117, L9N CM2380 L124B, QSC8.3 CM2250, QSC8.3 CM2880 C102, QSC8.3 CM554, QSC8.3 CM850(CM2850), QSL9 CM2250, QSL9 CM2250 L115, QSL9 CM2350 L102, QSL9 CM2350 L107, QSL9 CM2350 L118, QSL9 CM2350 L122, QSL9 CM554, QSL9 CM850(CM2850), QSL9 G CM558, QSL9 M CM2250 L106, QSL9.3 CM2880 L113

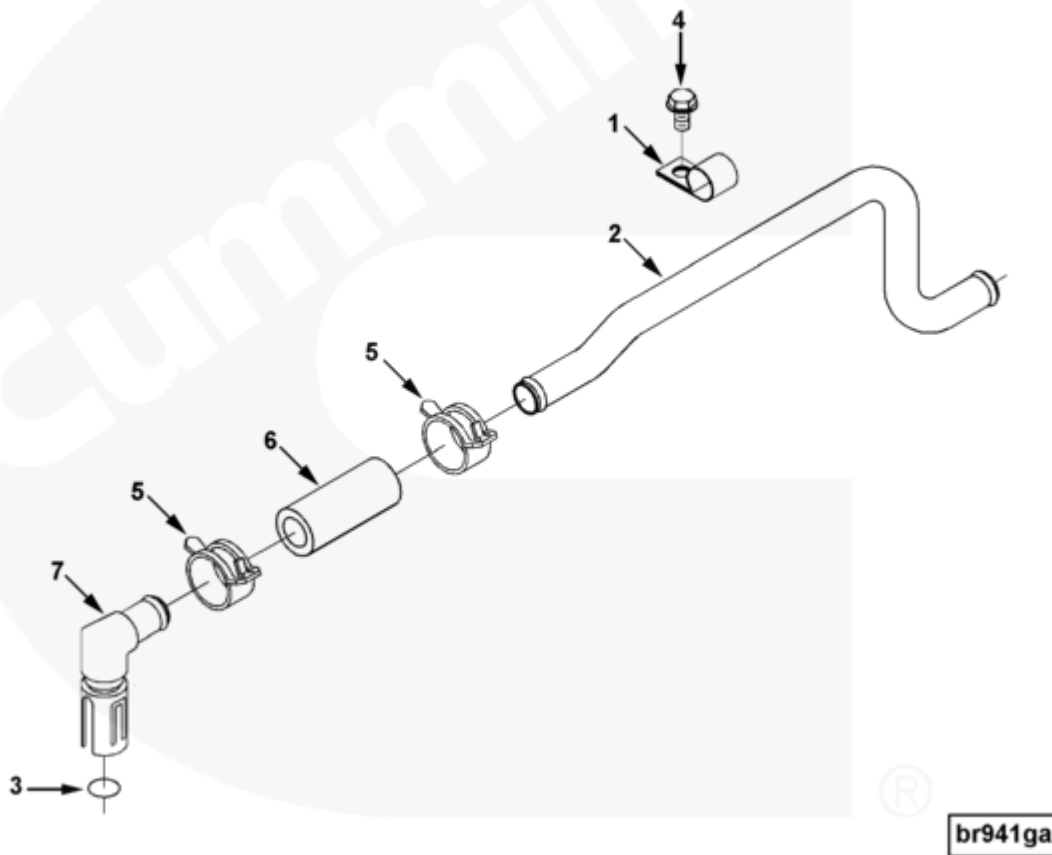
Cart	Ref No	Part Number	Part Description	Required	Remarks
View My Cart					
		BR9039-04	Crankcase Breather		MR - BREATHER, CRANKCASE...(More)

Breather Type: Open
					Breather Vent Tube End
					Location: Rear of Engine
					Breather Vent Location:
					Between 3 & 4
					Unique Characteristics:
					Parallel to Crank Centerline
					Rearward
					Engine Family: C Series
					Engine Aspiration:
					Turbocharged; Sea Water
					Aftercooled
					A Compatible Air Cleaner
					System Designed for Closed
					Crankcase Ventilation is
					Required for a Complete
					Closed Crankcase Ventilation
					System
<input type="checkbox"/>	1	<a href="#">202888</a>	Clip	2	
<input type="checkbox"/>	2	<a href="#">3866727</a>	Breather Tube	1	
<input type="checkbox"/>	3	<a href="#">3936331</a>	Rectangular Ring Seal	1	
<input type="checkbox"/>	4	<a href="#">3912072</a>	Self Tapping Metal Screw	2	M8 x 1.25 x 15
<input type="checkbox"/>	5	<a href="#">3937613</a>	Hose Clamp	2	
<input type="checkbox"/>	6	<a href="#">3918611</a>	Plain Hose	1	
<input type="checkbox"/>	7	<a href="#">3935113</a>	Vent Connection	1	Service With 3934865 Seal
