## Parts Catalog - Option Detail

Electronic Parts Catalog - Option Detail				
Option	Group	Graphic	Film Card	Date
OP9005	07.01	op900gg	T	01-MAR-92
Engines	4B3.9, 6A3.4, 6B5.9, B GAS INTERNATIONAL CM556, B4.5, B4.5 CM2350 B129B, B4.5 CM2350 B146C, B4.5 CM2350 B147B, B4.5 RGT, B4.5S, B5.9 G, B5.9 GAS PLUS CM556, B5.9 LPG, B5.9 LPG PLUS CM556, B6.7 CM2350 B121B, B6.7 CM2350 B135B, B6.7 CM2350 B136C, B6.7 CM2350 B148B, B6.7 G CMOH6.0 B125, B6.7N CM2380 B150B, B6.7S, F3.8 CM2350 F120B, F3.8 CM2350 F128C, F3.8 CM2350 F132B, F3.8 F102, G3.9, G5.9, G5.9 CM558, ISB (CHRYSLER), ISB CM2150, ISB CM2150 E, ISB CM550, ISB CM850, ISB/ISD4.5 CM2150 B119, ISB/ISD4.5 CM2150 SN, ISB/ISD6.7 CM2150 B120, ISB/ISD6.7 CM2150 SN, ISB/ISD6.7 CM2880 B126, ISB3.9 CM2220 B107, ISB4.5 CM2150, ISB5.9G CM2180, ISB6.7 2010 DCX PICKUP, ISB6.7 2013 DCX CHASSIS CAB, ISB6.7 CM2150 SQ, ISB6.7 CM2250, ISB6.7 CM2350 B101, ISB6.7 CM2350 B103, ISB6.7 CM2350 B142, ISB6.7 CM2670 B153B, ISB6.7 G CM2180 B118, ISBE CM2150, ISBE CM800, ISBE2/ISBE3 CM850, ISBE4 CM850, ISD4.5 CM2150, ISD6.7 CM2880 D101, ISF2.8 CM2220, ISF2.8 CM2220 AN, ISF2.8 CM2220 EC, ISF2.8 CM2220 ECF2, ISF2.8 CM2220 F101, ISF2.8 CM2220 F117, ISF2.8 CM2220 F12

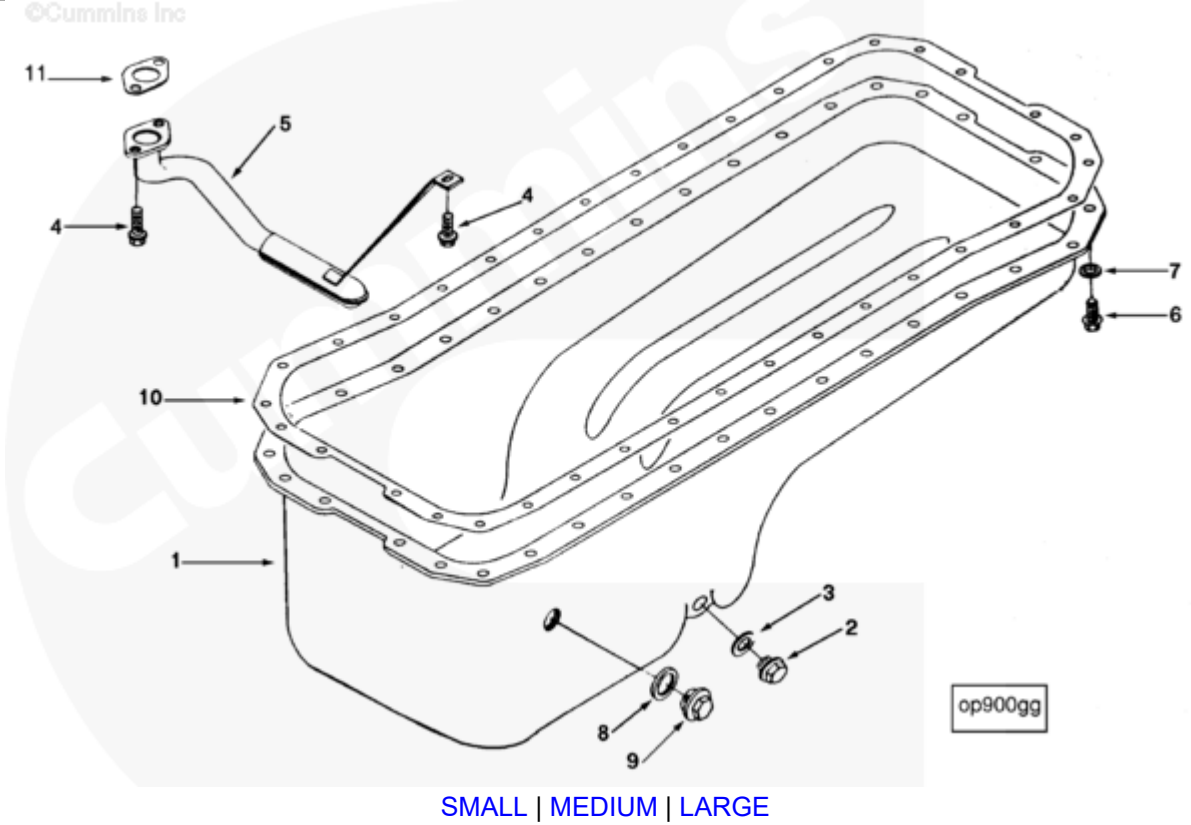
Cart	Ref No	Part Number	Part Description	Required	Remarks
<input type="button" value="View My Cart"/>					
		OP9005	Oil Pan		NOTE: Replaces OP9031....(More)

Shallow front sump oil
					pan. 22-1.5 hole for
					immersion heater.
					Capacity level in U.S.
					quarts: High, 15 quarts
					- low, 13 quarts.
					Angularity limit is abou
					40 deg. all directions
					for this pan.
	1	<a href="#">3915703</a>	Oil Pan	1	Serviced as 3900960
<input type="checkbox"/>	2	<a href="#">3911638</a>	Threaded Plug	1	M18 x 1.50
<input type="checkbox"/>	3	<a href="#">3900216</a>	Sealing Washer	1	
<input type="checkbox"/>	4	<a href="#">3900629</a>	Hexagon Flange Head Cap Screw	3	M8 X 1.25 X 16
<input type="checkbox"/>	5	<a href="#">3909373</a>	Lubricating Oil Suction Tube	1	
<input type="checkbox"/>	6	<a href="#">3907860</a>	Hexagon Flange Head Cap Screw	36	M8 x 1.25 x 25
<input type="checkbox"/>	7	<a href="#">3907537</a>	Spring Washer	36	
<input type="checkbox"/>	8	<a href="#">3902425</a>	Sealing Washer	1	M22
<input type="checkbox"/>	9	<a href="#">3904386</a>	Threaded Plug	1	M22 x 1.50 x 14

<input type="checkbox"/>	10	<a href="#">3911536</a>	Oil Pan Gasket	1	
	11	<a href="#">3914383</a>	Flange Gasket	1	Replace With 3938157
